**REPAIR, EVALUATION, MAINTENANCE, AND
REHABILITATION RESEARCH PROGRAM**

TECHNICAL REPORT REMR-CO-3

**CASE HISTORIES OF CORPS BREAKWATER
AND JETTY STRUCTURES**

Report 1
SOUTH PACIFIC DIVISION

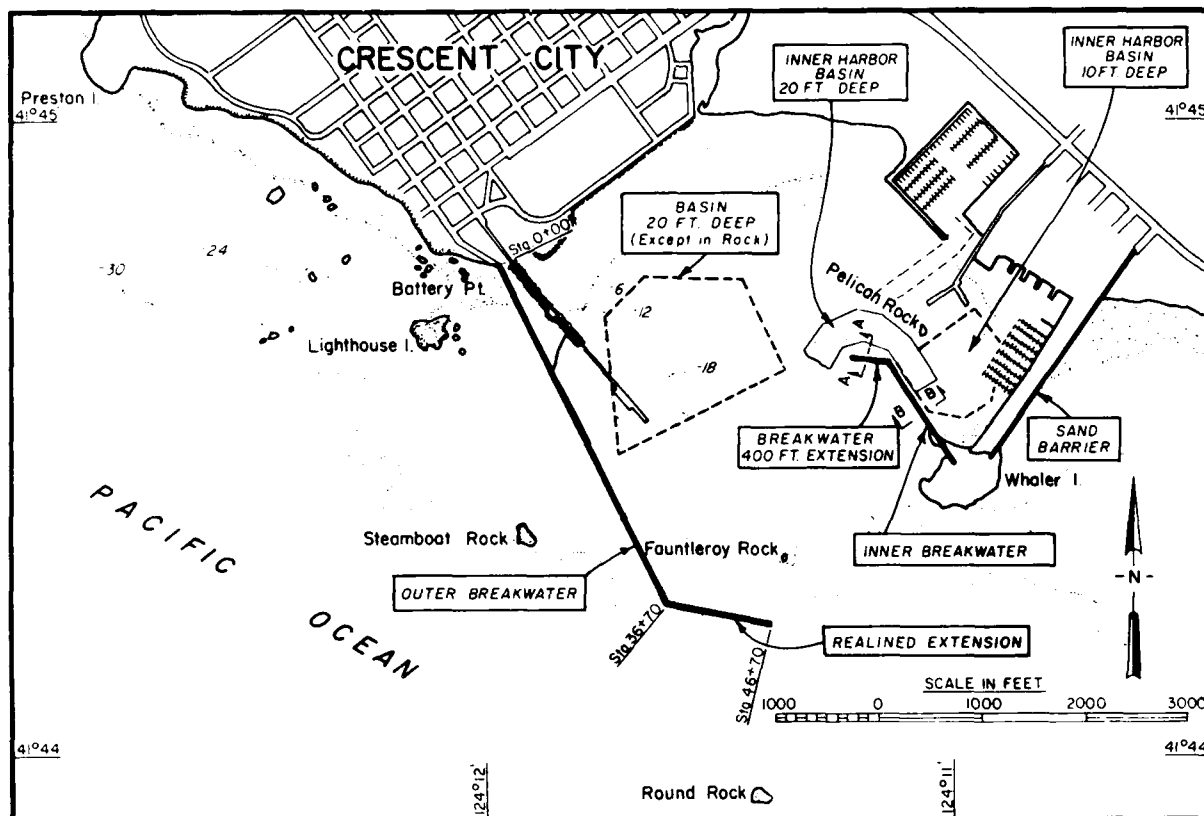
Figure 3. Crescent City Harbor, California

1948	A 1,000-ft-long extension of the original (outer) breakwater extending toward Round Rock (Figure 3) was completed. Ten- to 12-ton armor stones were used.
1948- 1949	During storms of 1948 and 1949, the 1,000-ft-long extension of the outer structure suffered considerable damage.
1950	The crest el of the entire outer breakwater, with the exception of a 300-ft segment (sta 12+50 to 15+50), was raised to +20 ft mllw with a 22-ft-wide concrete cap to prevent overtopping.
1950- 1951	Winter storm seasons resulted in further damage to the outer breakwater. Damages consisted of displacement of the concrete cap and armor stones down to about 0.0 mllw in all of the extension located seaward of sta 37+00.
1952	A modification was authorized which provided for a 1,000-ft-long extension of the outer breakwater on a bearing of S80° E (Figure 3) and for abandonment of the existing structure seaward of sta 36+70.

Date(s)	Construction and Rehabilitation History
1957	The 1,000-ft-long outer breakwater extension, as authorized in 1952, was completed. Twelve-ton stone protection was used from sta 36+70 to 41+20. From sta 41+20 to 46+70, 25-ton unreinforced tetrapods (1,836 units) were placed on the seaward slope (Figure 5). Model tests were conducted (US Army Engineer Waterways Experiment Station (WES), Hydraulics Laboratory (HL) 1953, 1956).
1957- 1964	Damages occurred to a portion (sta 36+70 to 41+20) of the outer breakwater, and in 1964 were repaired using 12-ton stones and 140 25-ton tetrapods. The tetrapods were not model tested for their adequacy for placement in this area, and they were destroyed over a period of years.
1973	Repairs were made to the concrete cap of the outer breakwater between sta 35+40 and 37+00.
1974	Rehabilitation of the outer breakwater between sta 34+70 to 37+00 was completed. Two layers of 40-ton unreinforced dolosse (246 units) were placed on the seaward slope.

1974	Construction of a 400-ft-long extension of the inner breakwater was completed (Figure 3). Model testing was conducted to determine optimum wave conditions (Senter and Brasfield 1968, Senter 1971).
1979	Repairs were made to the following reaches of the outer breakwater using 18- to 30-ton stone: sta 19+00 to 20+00, 22+00 to 24+00, 24+60 to 27+20, 28+90 to 29+50, 30+50 to 31+00, and 37+00 to 41+20. Repairs to sta 15+50 through 17+50 also were made using stone in the 14- to 25-ton range.
1983	Major storms in the winter of 1983 resulted in broken dolosse on the outer breakwater. Estimated damage to the structures was \$4,400,000.
1984	Approximately 23,300 tons of stone were placed to repair various sections of the outer breakwater between sta 17+30 to 33+90.
1986	The outer breakwater is presently in poor condition. The problem area is primarily between sta 34+70 through 37+00 where missing and/or damaged dolosse are apparent. A contract was issued to rehabilitate the dolosse section of the outer structure (sta 34+70 through 37+00) with 700 fiber-reinforced 42-ton dolosse. The dolos perimeter used special placement, and the dolosse on the outer portion of the seaward transition were entrenched and buttressed with 25-ton stone (Baumgartner, Carver, and Davidson 1985). About 80 of the constructed dolosse were stockpiled on the leeward side of the jetty for repair contingencies. This rehabilitation effort was also used to gather data on prototype forces on dolosse. Twenty of the dolosse (painted red) were instrumented and placed in the main dolos section at about sta 36+00. As of this date, no data have been received from the prototype dolos study.

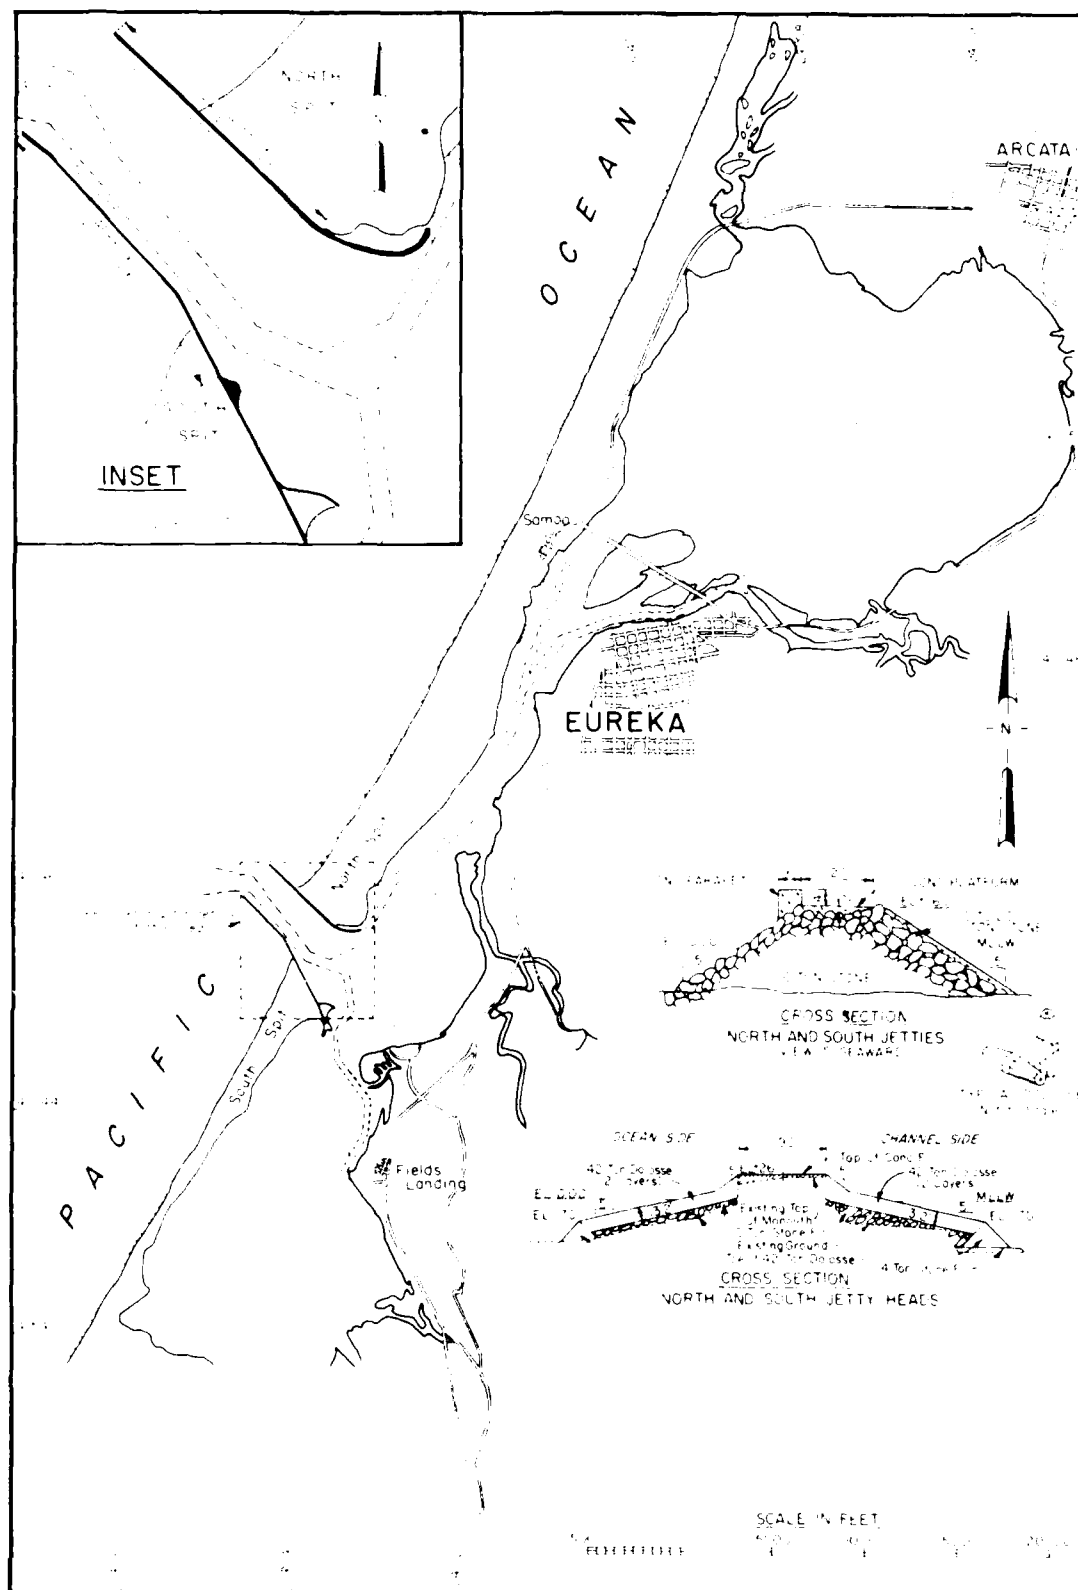
Figure 6. Humboldt Harbor and Bay, California

Date(s)	Construction and Rehabilitation History
1931- 1932	Extensive repairs were made to the outer ends of both jetties. Precast concrete blocks (4 by 9 ft) were used in lieu of stone and piled one on top of another for constructing the forms for concrete monoliths. North jetty repairs using 1,200 cu yd of concrete* were completed in 1931 at a cost of \$53,246. In 1932 north jetty repairs using 266 cu yd of concrete and south jetty repairs using 15,986 cu yd of concrete were completed for \$247,038.
1933	North jetty repairs using 4,748 cu yd of concrete and 6,435 tons of stone and south jetty repairs using 926 cu yd of concrete were completed for \$105,932.
1935	North jetty repairs using 1,370 cu yd of concrete were completed at a cost of \$17,366.
1936	North jetty repairs using 1,203 cu yd of concrete and south jetty repairs using 1,209 cu yd of concrete were completed at a cost of \$28,933. It was determined by this time that the rectangular concrete blocks were moved easily by the sea. Large stone, however, was not obtainable at a reasonable price and was replaced by concrete blocks. When placed in the parapet, the blocks were concreted in place.

1937	South jetty repairs using 1,552 cu yd of concrete were completed at a cost of \$25,400.
1939	Heavy storms caused great damage to both jetties. The monoliths at the outer end of the south jetty were undermined, causing them to tilt and sink. Breaches occurred in the jetty immediately shoreward of the monolithic end. A partial breach occurred through the north jetty just shoreward of its monolithic end. In addition, considerable damage was done to the side slopes of both jetties. During the year south jetty repairs were completed using 12,450 cu yd of concrete at a cost of \$151,025.
1940	North jetty repairs using 7,418 cu yd of concrete and 2,200 tons of stone and south jetty repairs using 29,772 cu yd of concrete were completed at a cost of \$311,848.
1941	North jetty repairs using 15,158 cu yd of concrete and 1,705 tons of stone were completed at a cost of \$141,220.
1942	North jetty repairs using 8,809 cu yd of concrete were completed for a cost of \$124,220.

1957- 1958	Severe winter storms deteriorated the north and south jetties to such an extent that repair work constituted a major construction project.
1958	Mass concrete was poured to fill eroded areas on crests, and armor stones were replaced in areas that were breached and washed out. Concrete blocks (11 by 11 ft) weighing 100 tons and 12-ton tetrahedrons were placed on the heads of both jetties.
1959	Major side slope losses on the south sides of both the north and south jetties occurred.
1960- 1963	Rehabilitation of both jetties was accomplished. Jetty trunks were repaired with 12-ton stones placed on 1V:1.5H slopes in the eroded areas. Jetty heads were reconstructed using 20-ton blocks to form head perimeters, and centers were filled with mass concrete. Two-hundred and fifty 100-ton concrete blocks were placed around the seaward tip of the south Jetty head. The concrete monolith at

Date(s)	Construction and Rehabilitation History
	seaward end of the north jetty was completed in 1961 and within the year was undermined by wave action resulting in part of the monolith breaking off. The monolith was repaired by placing rocks around the head section on 1V:2H side slopes and grouting the rocks with concrete. The elevation of the concrete at the north jetty was raised to +25 ft mllw and at the south jetty to +26 ft mllw at the tip. The heads were protected with 12-ton stones with a cover layer of 100-ton concrete blocks.
1963- 1965	Winter storm waves washed away most of the newly placed 100-ton concrete blocks.
1969- 1970	The concrete monolith at south jetty was undermined and broken. Heads of both jetties were totally destroyed.
1971- 1972	Rehabilitation of both jetties was completed. Concrete monoliths were reconstructed, and 42-ton dolosse were placed around the seaward quadrant of both jetty heads. Four unreinforced, 1,271 steel-reinforced, and 17 steel-fiber-reinforced dolosse were placed on the north jetty; and 22 unreinforced and 1,423 steel-reinforced dolosse were placed on the south jetty head. Dolosse (43-ton) also were placed on the shoreward transition sections of both jetty heads. Two layers of dolosse were placed using a concentration of 11 dolosse per 1,000 sq ft of slope. Cost of this work was \$10,108,764. Model testing was conducted prior to these repairs (Davidson 1971).

1973	South jetty repairs using concrete and stone were completed at a cost of \$20,400.
1975	An earthquake of 5.2 magnitude on the Richter scale occurred near the site. Inspection trips subsequent to the earthquake revealed fresh cracks along the south jetty running along the edges of the crest and slope for a distance of about 800 ft on the channel side and 300 ft on the seaward side. Blowout holes also were observed at several locations on the south jetty. On the north jetty, three of the dolosse had moved about 50, 100, and 150 ft from the placement area, respectively. Only minor settling of the remaining dolosse had occurred, and no cracking or unraveling of the dolosse units was apparent.
1977	South jetty repairs using concrete and rock were completed. Approximately 15,000 tons of stone ranging from 1 to 20 tons were used for these repairs.
1977- 1978	The jetties were subjected to severe storms combined with high tides and winds. On occasion, waves covered both jetties over their entire lengths. Waves also were observed breaking over the dolosse and concrete monoliths of the jetty heads. North jetty repairs using stone were completed at a cost of \$450,000.

Date(s)	Construction and Rehabilitation History
1978	An inspection revealed that the north jetty slope was eroded at several locations, and 12 blowout holes were apparent in the concrete cap. Also, at the north jetty head, waves had broken away a 20-ton concrete block from the concrete monolith which washed across the monolith and was resting against a tip of a dolos. The slope of the south jetty had eroded in numerous locations, and the parapet wall had broken at four stations. Nineteen blowout holes were observed in the south jetty concrete cap. Also a 7-ft stone had broken out of the parapet wall and was deposited on the concrete cap.
1983	Major storms resulted in an estimated \$2,000,000 in damages to the jetties.
1984	Repair of the south jetty consisting of 4,900 tons of 15- to 25-ton stones and replacement of 20-ton concrete blocks at the jetty head was completed. Also 16,665 tons of 15- to 25-ton stones and 16,665 tons of 18- to 31-ton stones were stockpiled on the harbor side of the jetty.

1985	Repair of the jetty heads was completed using a total of approximately 1,000 42-ton dolosse in various areas and the construction of toe berms.

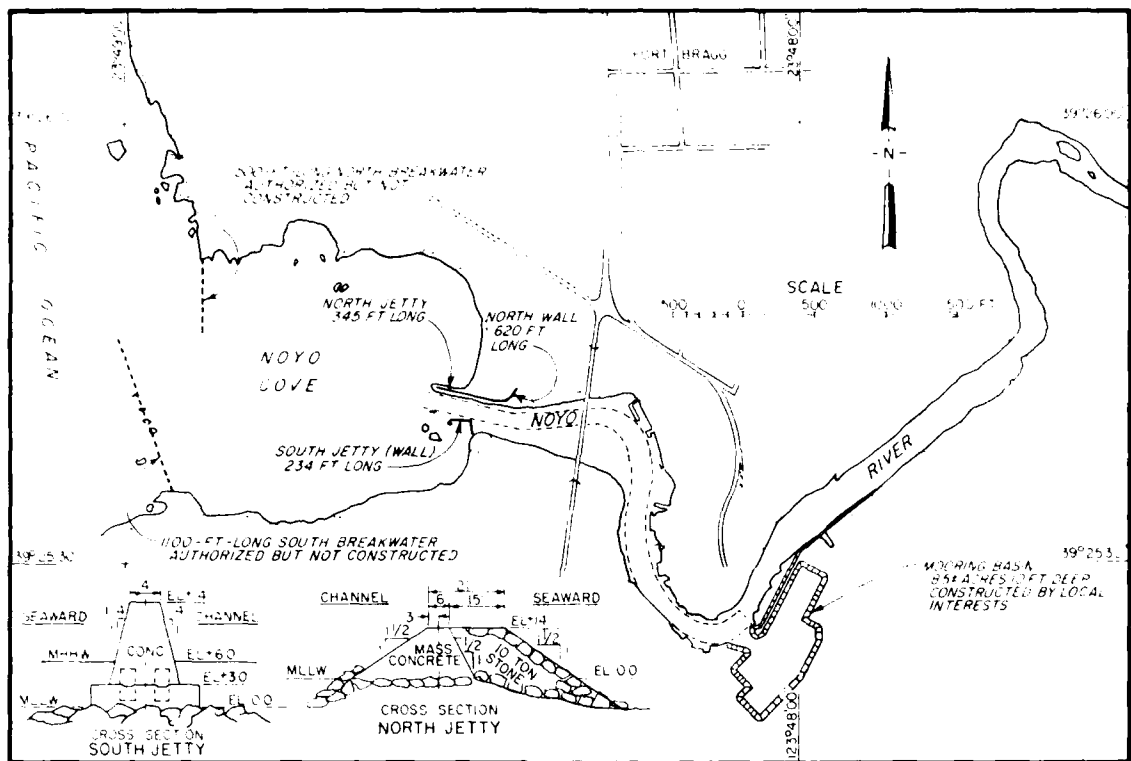
Figure 7. Noyo River and Harbor, California

<u>Date(s)</u>	<u>Construction and Rehabilitation History</u>
1924	Construction of two jetties across a sand bar was completed at the mouth of Noyo River. These were rubble-mound structures spaced approximately 125 ft apart. The initial lengths of the north and south jetties were 648 and 110 ft, respectively.
1931	Work at the Noyo River entrance, which included dredging, rock removal, and reconstruction of the jetties, was completed. The jetties were constructed to their present lengths (Figure 7). The north jetty was constructed of mass concrete. It was 345 ft long and connected to a 620-ft-long concrete wall. The south jetty was constructed 234 ft long with concrete. Both structures had crest els of +14 ft mllw.
1945	A 1,100-ft-long outer rubble-mound south breakwater was authorized (Figure 7). This structure has not been constructed.
1954	Stone (10-ton) was added to the seaward side of the north breakwater (Figures 7 and 8).

1961	Minor rehabilitation of the jetties and north wall was completed.
1962	A 500-ft-long outer rubble-mound north breakwater was authorized (Figure 7). This structure has not been constructed.
1970	The two outer breakwaters authorized by the Acts of 1945 and 1962 were reclassified from an active to inactive category. They were not economically feasible because of the high cost of construction and maintenance. Model testing of the structures was conducted (Wilson 1967).
1983	Restoration of the north jetty head was completed. Materials used consisted of approximately 2,500 tons of capstone, 10 cu yd of concrete, 1,500 cu yd of sandfill, and 4,100 tons of quarystone fill.
1986	The jetties are presently in good condition. Model testing currently is being conducted to optimize the location of a structure in the immediate area of the River entrance (Bottin, in preparation).

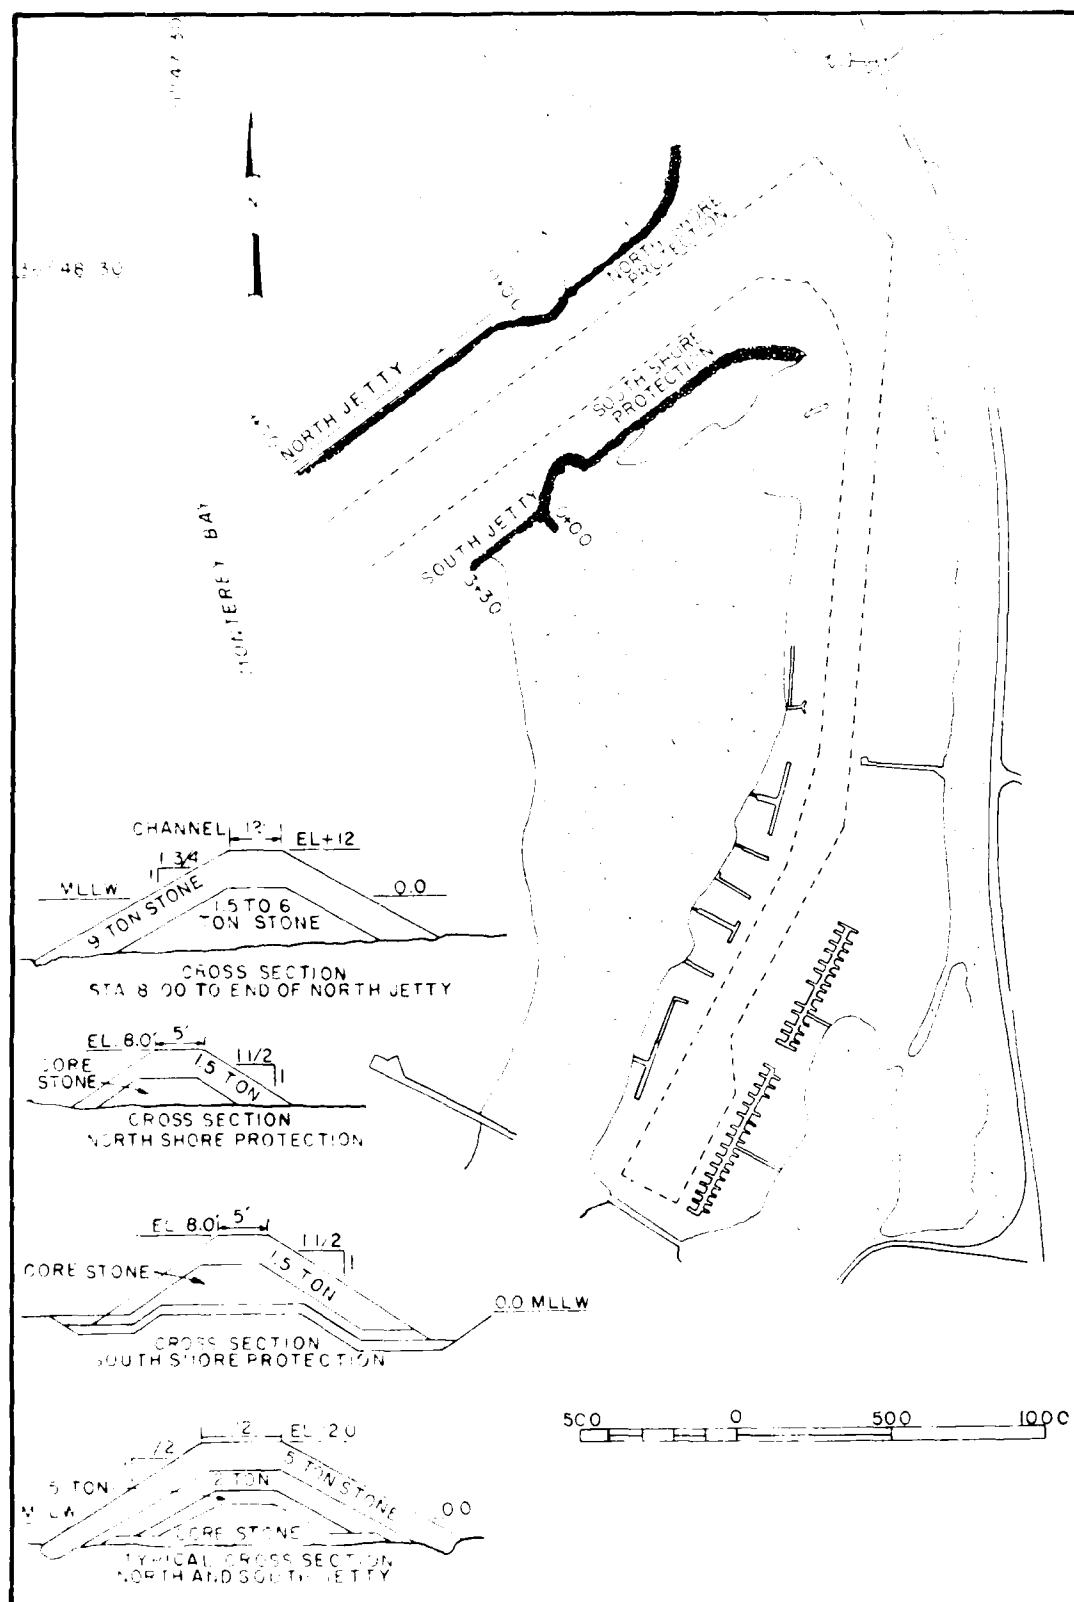
Figure 19. Moss Landing Harbor, California

<u>Date(s)</u>	<u>Construction and Rehabilitation History</u>
1947	Construction of protective jetties at the site was completed to stabilize the entrance (Figure 19). The north and south jetties are 900- and 330-ft long, respectively, and are roughly parallel. Crest els of the jetties range from +8 ft to +12 ft mllw, and side slopes vary from 1V:1.5H to 1V:1.75H. During project construction severe storms resulted in scouring and deep cutting of the sand adjacent to the jetties. Emergency stone placement was undertaken along the south jetty from the shore to a point 320 ft seaward. Stone protection for the north jetty was placed throughout its 900-ft length, and additional placement was made along the north and south shorelines of the jetties. A total of 47,946 tons of stone was required for this work.
1949	To add permanence to the emergency work of 1947, additional armor stone was placed on the previous enrockment. This effort required a total of 24,625 tons of stone.

1949- 1965	Severe erosion around the jetties and the unprotected shorelines adjacent to them was experienced during this time frame.
1966- 1967	Approximately 235 ft of the north jetty and the entire length of the south jetty were repaired. Also about 280 ft of curved revetment work was added to the north jetty and about 380 ft added to the south jetty. This work required the placement of 77,560 tons of stone. The north jetty head was not repaired because of the movement of the canyon head and the possibility that damage may occur to any repairs in that vicinity.
1975	A field inspection revealed the jetties in satisfactory condition except for damage on the seaward ends due to erosion and subsequent stone displacement. The deep submarine canyon head at the seaward end of the north jetty appeared to have stabilized.
1976	A basis for design of repairs to the jetties and revetment was prepared. Estimated cost of these repairs was \$290,000, and approximately 7,400 tons of stone would be required.

1986	Work is still required at the jetty heads. Except for the erosion at these locations, the jetties historically have performed satisfactorily and suffered relatively minor damages.

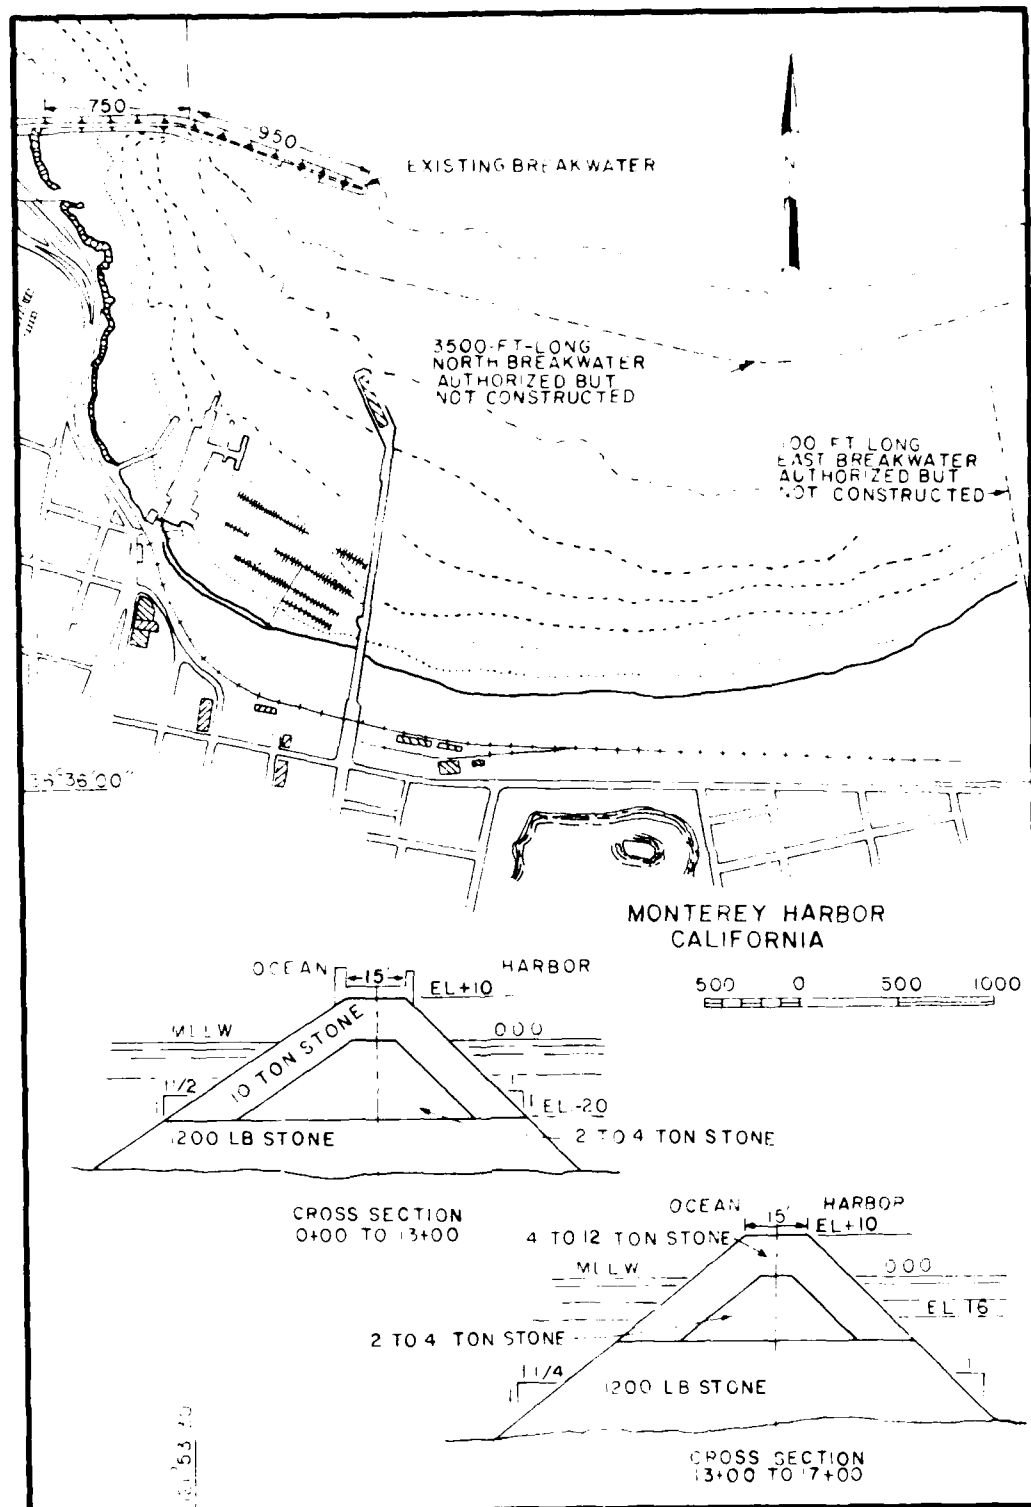
Figure 20. Monterey Harbor, California

Date(s)	Construction and Rehabilitation History
1932	The construction of a 1,300-ft-long rubble-mound breakwater was completed (Figure 20). The crest el of the structure was +10 ft mllw, and the side slopes were 1V:1H on the harbor side and 1V:1.5H on the ocean side. The armor stones used weighed 10 tons each.
1934	A 400-ft rubble-mound extension to the breakwater was built under the Public Works Administration Program (Figure 20). The extension was constructed with a crest el of +10 ft and with 1V:1H side slopes on the harbor side. Side slopes on the ocean side were 1V:1.25H from the existing ground to el -16 ft mllw and 1V:1.5H from el -16 to +10 ft mllw. Armor stones used ranged from 4 to 12 tons. Total cost of the breakwater through 1934 was \$652,951.
1960	Improvements consisting of a 3,300-ft-long north breakwater and a 1,100-ft-long east breakwater (Figure 20) were authorized. These structures were never constructed; however, model tests were conducted to optimize the improvements (Chatham 1968).

1969	Model tests for a proposed tribar breakwater section were conducted (Davidson 1969).
1974	The project authorized in 1960 was reclassified as inactive due to lack of local support.
1986	There is no history of maintenance of the breakwater, and it is in satisfactory condition.

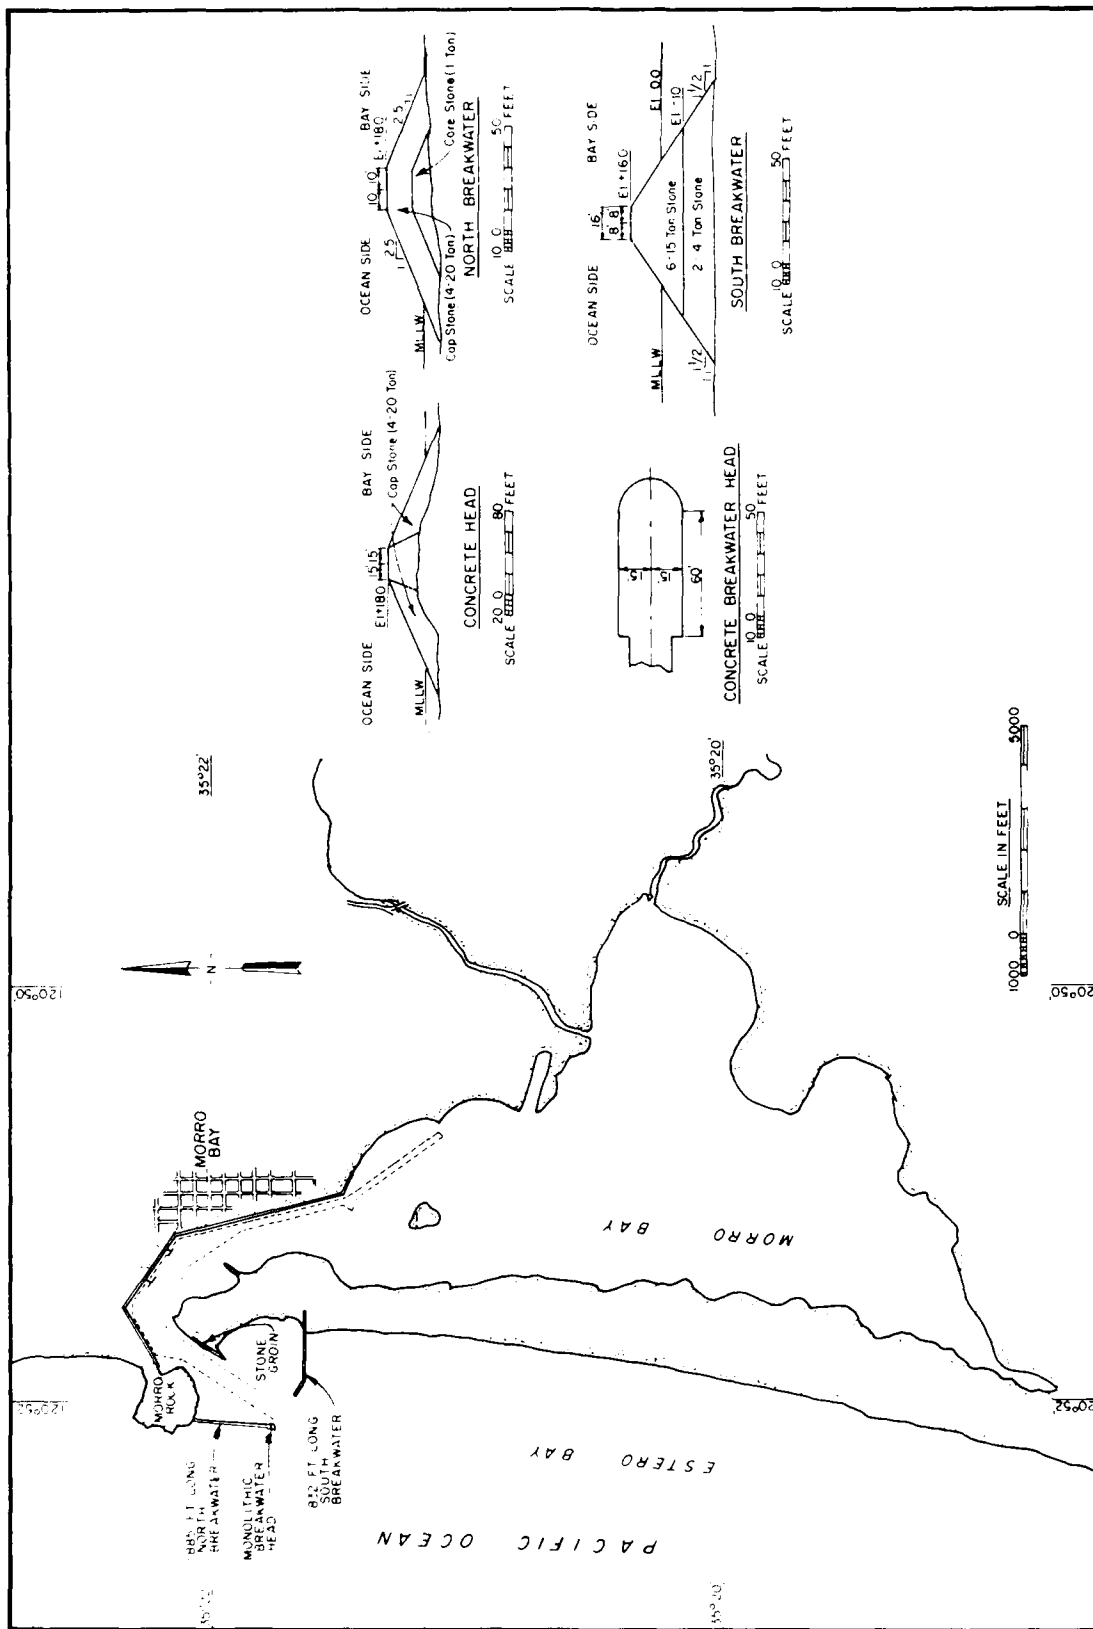
Figure 21. Morro Bay Harbor, California

Date(s)	Construction and Rehabilitation History
1942	A 1,000-ft-long north breakwater was constructed, and a 1,832-ft-long south breakwater was completed at the site (Figure 21) to serve as a base for naval patrol craft. The structures were rubble-mound and built at an el of +16 ft mllw with 1V:1.5H side slopes and a crest width of 16 ft.
1943	
1943- 1944	Storm waves during this period damaged the north breakwater. The south breakwater received no appreciable damage.
1945	The north breakwater was repaired and extended to 1,800 ft in length. This work also included widening the crest from 16 to 20 ft. The project was adopted and completed under the supervision of the CE using funds provided by the US Navy.
1946	The north breakwater again suffered damage from storm waves.
1948	Maintenance work was performed on the north breakwater. Damaged sections of the structure were restored, and the cap was bound with concrete across the crest to an el of -2 ft mllw on both sides.

1949- 1960	The north breakwater continued to deteriorate, and shoaling occurred in the channels. The south breakwater still had suffered no observable damage since its construction in 1943.
1964	The north breakwater was reconstructed at a cost of \$1,561,882. The new rubble-mound structure was built at an el of +18 ft mllw, with a 20-ft-wide crest and 1V:2.5H side slopes. The structure was rebuilt about 100 ft bayward of the original north breakwater location and extended to 1,885 ft in length (Figure 21). The breakwater included larger armor stone than the original structure. Also included was a concrete monolithic breakwater head. Model tests were conducted (Jackson 1961).
1983	Major storms resulted in approximately \$1,430,000 in damages to the breakwaters.
1985	Maintenance repair of the north and south breakwaters was completed which included the placement of approximately 18,000 tons of capstone. Capstones ranged in weight from 6-21 tons each.

1986	The structures presently are in good condition.

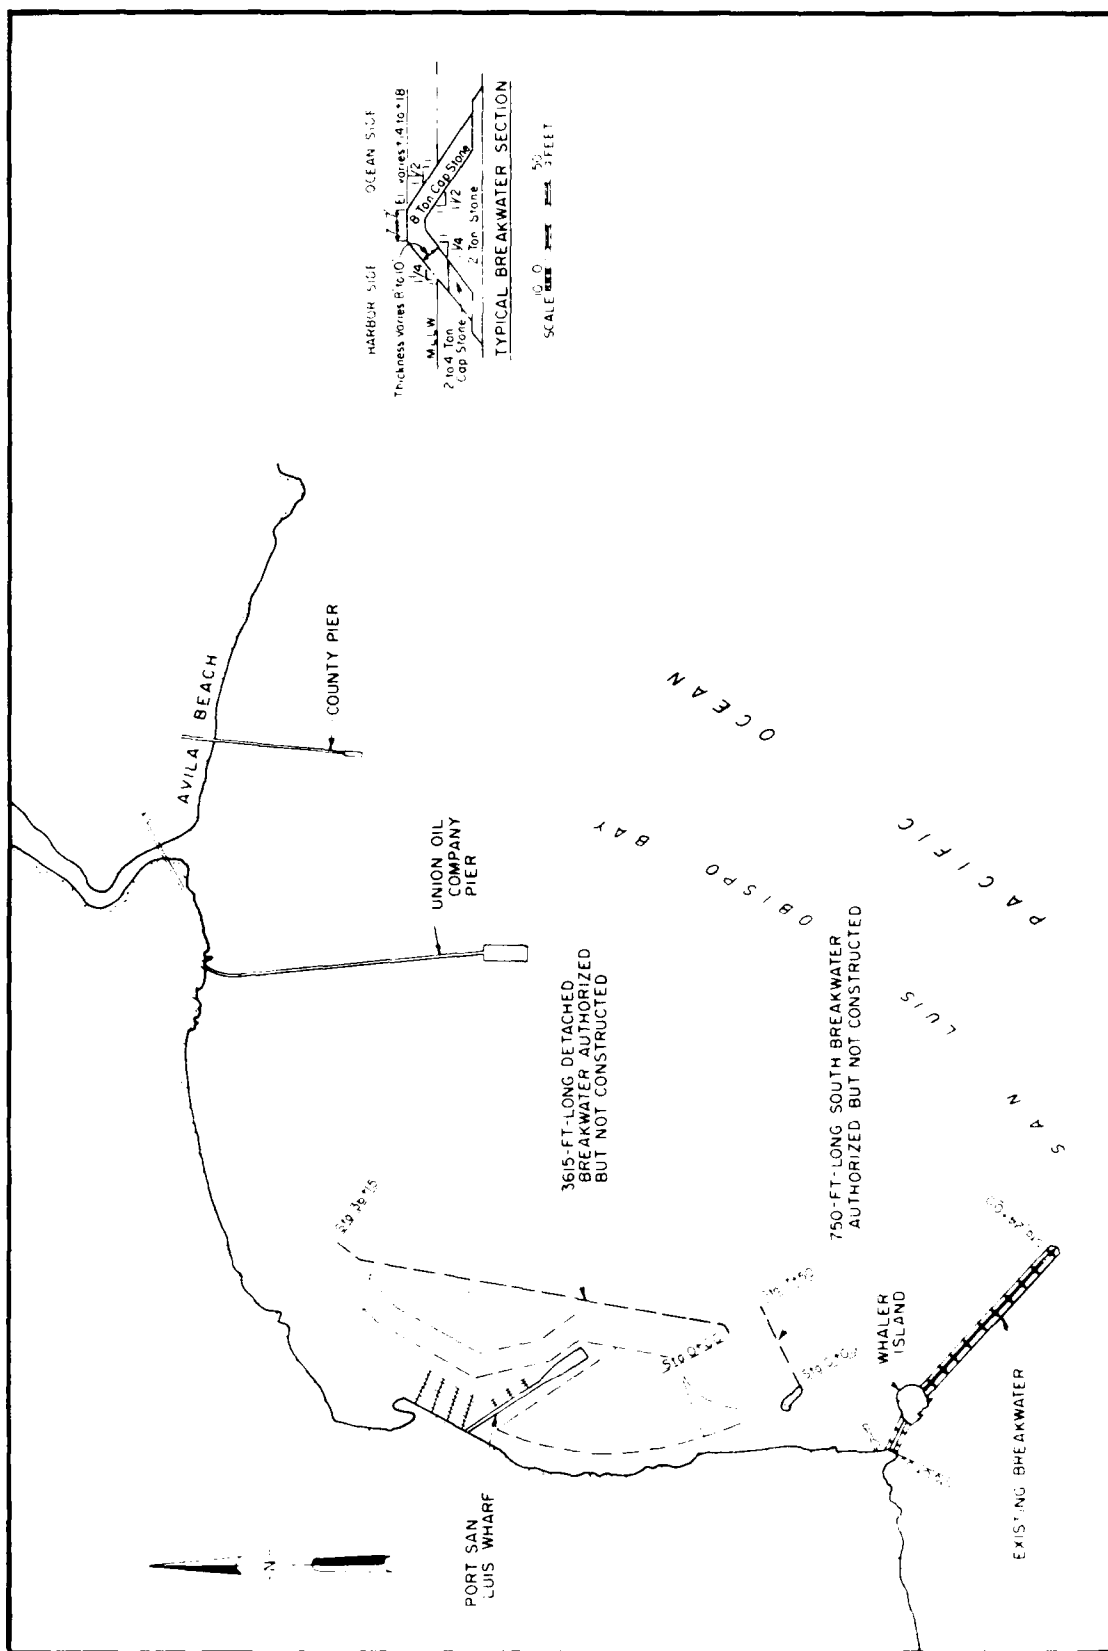
Figure 22. Port San Luis, California

<u>Date(s)</u>	<u>Construction and Rehabilitation History</u>
1888-1913	Construction of a rubble-mound breakwater, approximately 2,400 ft long, was completed at the site (Figure 22) during this time frame. The crest el of the structure varies from +14 ft to +18 ft mllw with a 14-ft width. The side slopes are 1V:1.5H on the ocean side and 1V:1.25H on the harbor side.
1924	The structure was breached in a zone about 300 ft seaward of Whalers Island (Figure 22) by storm waves.
1927	The breach formed in 1924 was filled with a concrete cap.
1931	The concrete cap placed in 1927 was washed away because of storm wave activity. Also, the head of the breakwater was damaged.
1935	Repairs were made to damaged areas of the structure. The slopes in the damaged zones were covered with 14-ton stones to els of -10 to -15 ft mllw.
1976	Modification of the existing project was authorized. Included were a 750-ft-long south breakwater, a 3,615-ft-long detached breakwater, and dredging of associated channels and anchorage areas (Figure 22). These structures have not been constructed.

1983	Major storms resulted in approximately \$578,000 in damages to the breakwater.
1984	Maintenance repair of the existing breakwater was completed which consisted of approximately 8,700 tons of capstone placement and resetting of 40 existing capstone. The crest width of the structure was increased to 20 ft. Plans and specifications for construction of the modified project (authorized in 1976) were about 80 percent complete.
1986	The breakwater currently is in satisfactory condition.

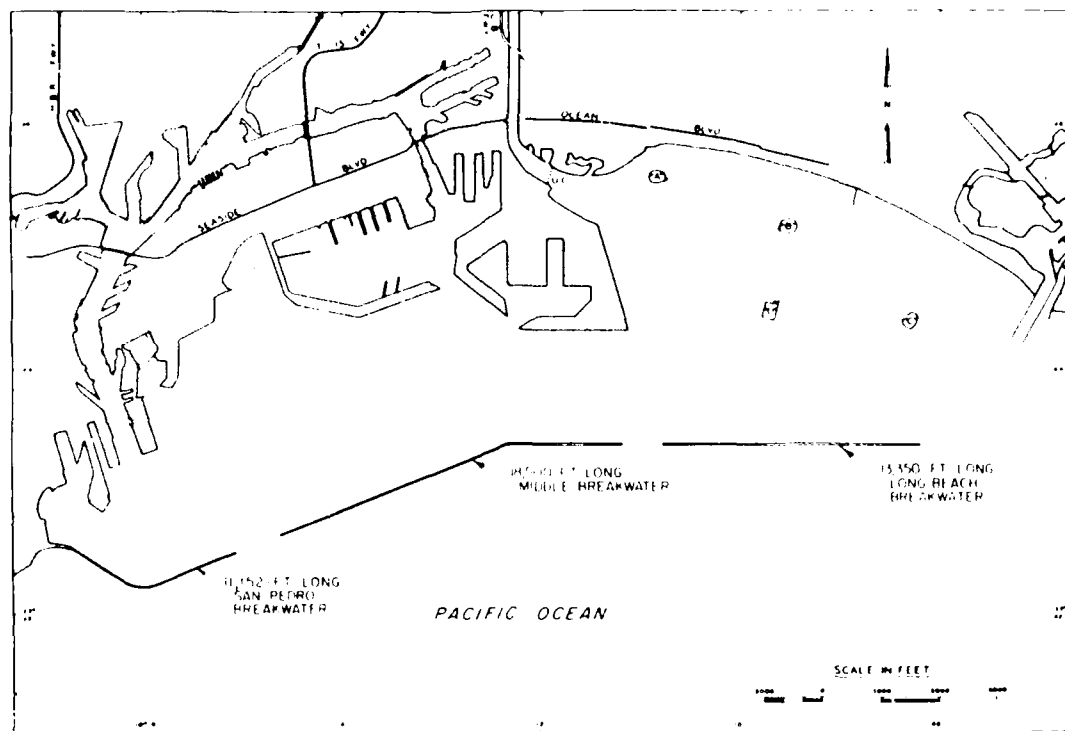
Figure 29. Los Angeles and Long Beach Harbors, California

1942- 1960	Construction of the 13,350-ft-long rubble-mound Long Beach Breakwater (Figure 29) occurred during this period. With the exception of the breakwater core el (Figure 30) the cross section of this structure was similar to that of the middle breakwater.
1947	Repairs to the middle breakwater were accomplished for a cost of \$786,700.
1983	Winter storms resulted in extensive damage to the San Pedro Breakwater. The structure was breached in an area immediately seaward of the curved portion of the breakwater. Model tests were conducted after the damage (Carver 1984, Baumgartner, et al. 1986), and restoration of the San Pedro Breakwater was subsequently completed. Work consisted of the placement of approximately 25,000 tons of salvage stone and new angular stones ranging from 15 to 25 tons each. Where voids occurred on the crest after this stone placement, concrete was pumped into flexible temporary forms to complete the repair.

1986	The breakwaters presently are in good condition.
